Dully Residence

Address: **NE Landon Road, Belfair, WA**
 Region: **Southern end of the Hood Canal**
 Designer: **Michael Dully**
 Contractor: **Butch's Bulldozing**
 Owner: **M. Dully**
 Shoreline Type: **Beach**
 Project Type: **Large Woody Debris
Buried Rock Revetment**
 Wave Energy: **Low**
 Tides: **MHHW: +11.4
Extreme High: +15.0
Extreme Low: -4.5**
 Cost: **\$15,500**
 Date Completed: **September 1998**

Floral Point, SUBASE Bangor

Indian Island

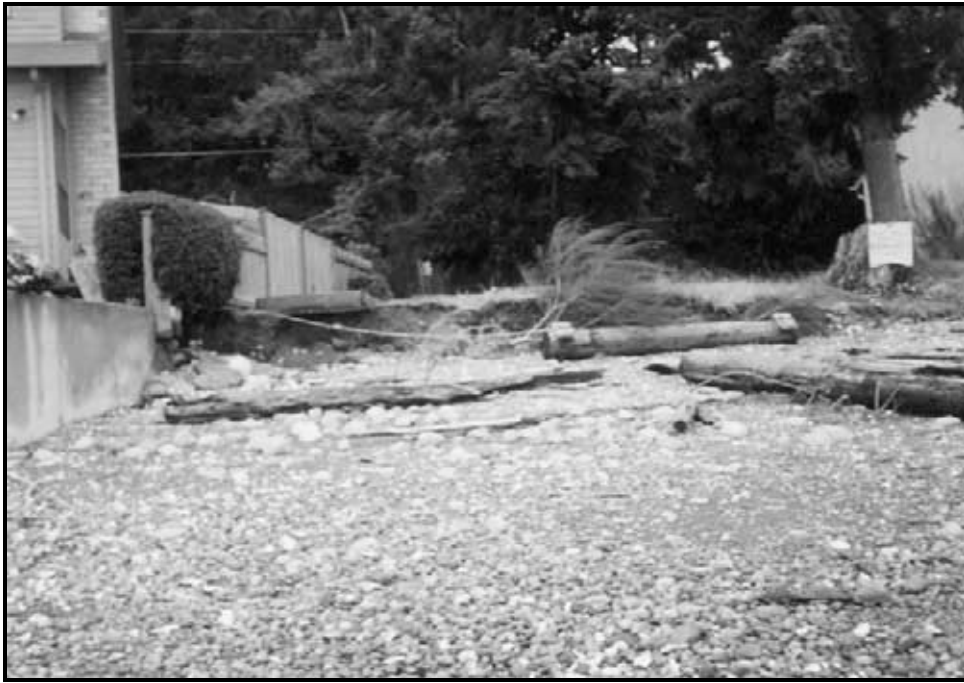
Coast. By 1994, when the Dullys returned to Washington, between 10 and 15 feet of beach had eroded. The loss was most dramatic on the west end of the sight where reflected wave energy from the neighboring bulkhead is severe.

Figure 1. West end of site prior to construction. Note significant scarping and the amount of the neighboring bulkhead's wing wall that is exposed.

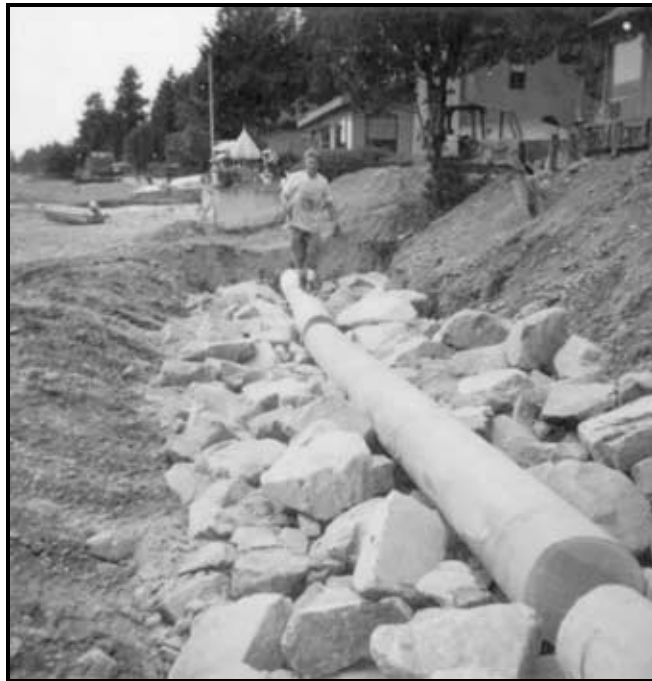
Figure 2. View of west end of site during construction. Large amount of rock provides an emergency bottom in the event that the beach drops (*Photo: Jim Brennan*).

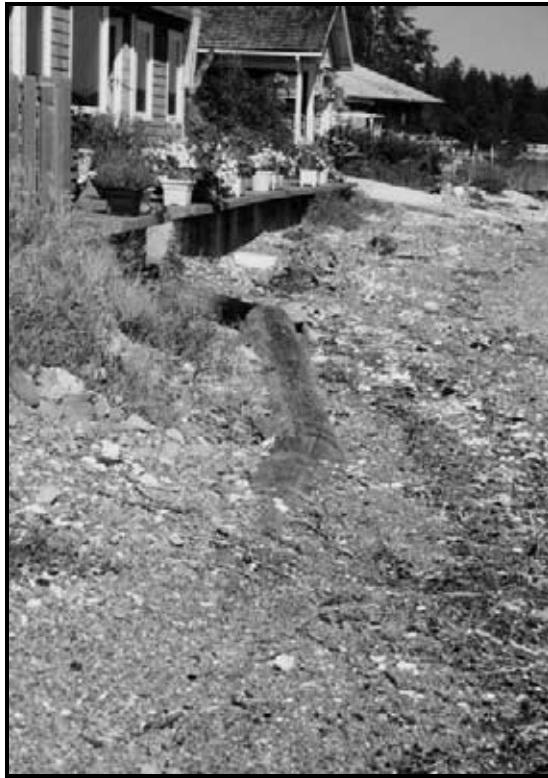
Figure 3. View of east end of site following completion of project. The logs rise out of beach and curve back to meet neighbor's bulkhead.

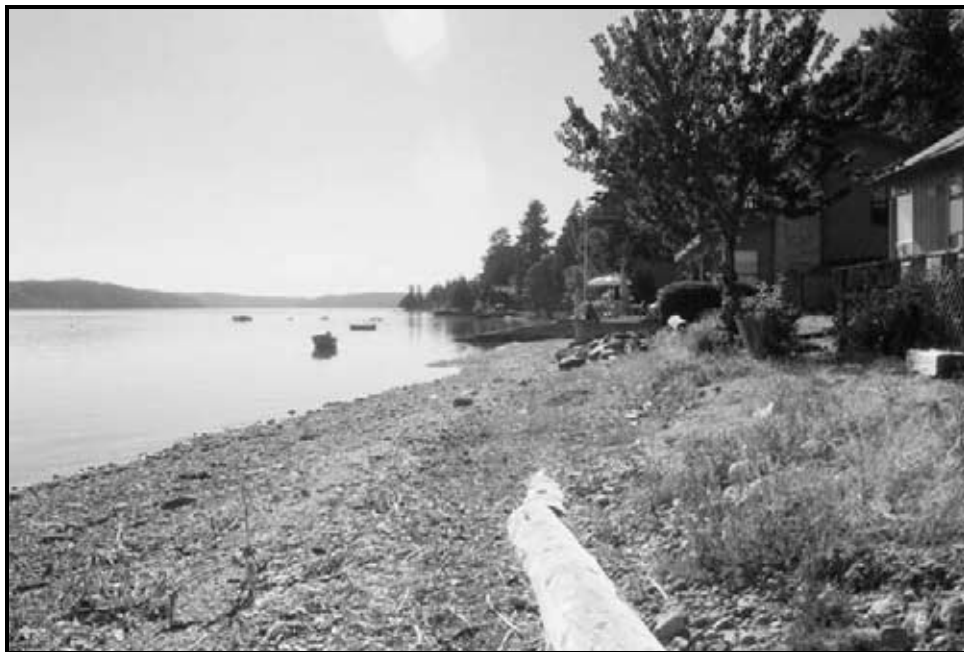
No official monitoring is being performed at the site. There still seems to be a small erosion problem at the west end where problems were the most extreme prior to the project. However, during the first winter (1998-'99) a significant amount of gravel was deposited on the beach and was retained above the anchored logs. One year after installation, when the photos for this report were taken, the logs were buried across most of the site rising out of the sand at either end of the site.

Figure 4. View of site from the west. Logs have been covered by accretion along much of beach. The logs reemerge at the far (west) end where a pile of rock reduces the impacts of the neighboring bulkhead.

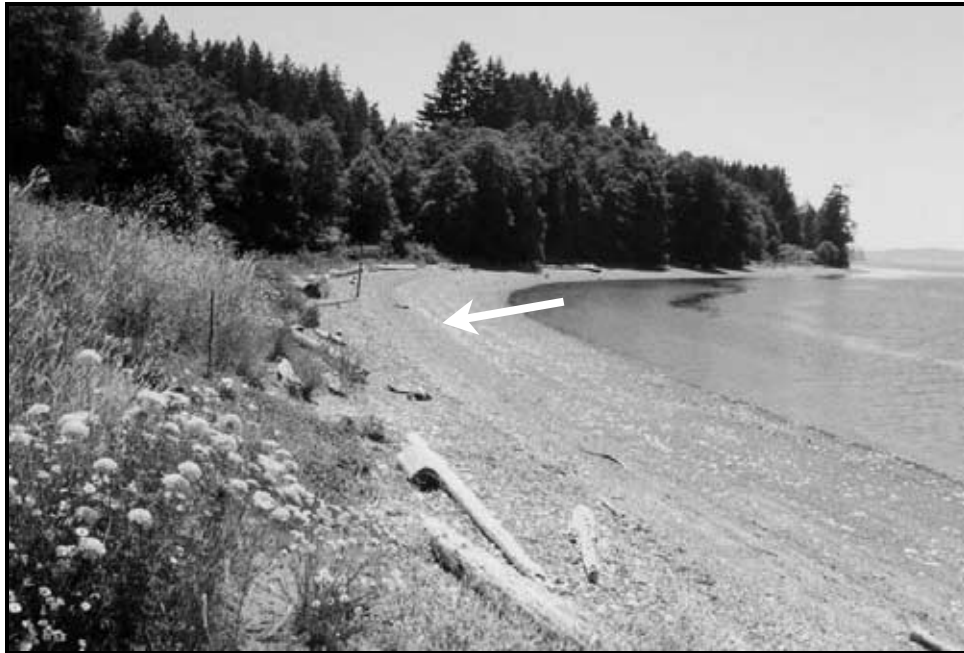
Figure 1. Southwest facing portion of site. Southern limit of project area is marked with arrow.

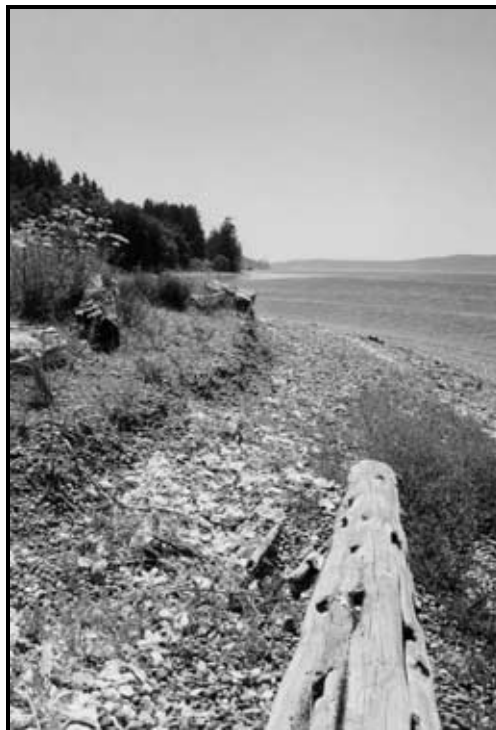
Figure 2. View south from western point. Photo provides good profile perspective of the work. Note that vegetation has established on the bench and a vegetated berm has begun to form on the upper beach.

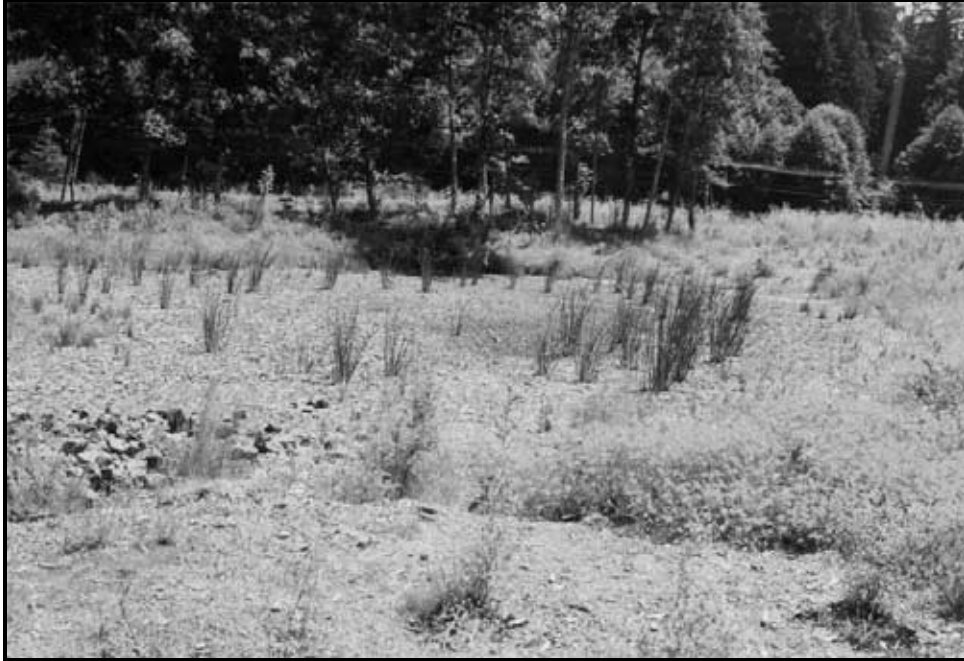
Figure 3. Wetland reconstruction on cap. This area was relatively dry when photos were taken (July), but the area in the center is wet and marshy earlier in the year.

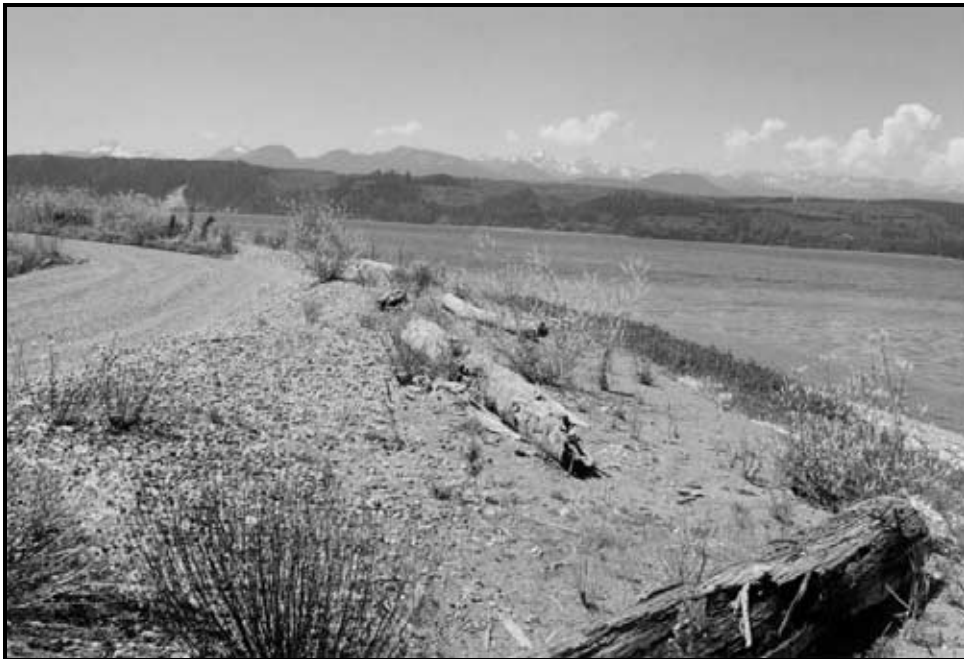
Figure 4. Slope and backshore with road. The position of the road affected the overall design of the project and the grade chosen for the upper beach.

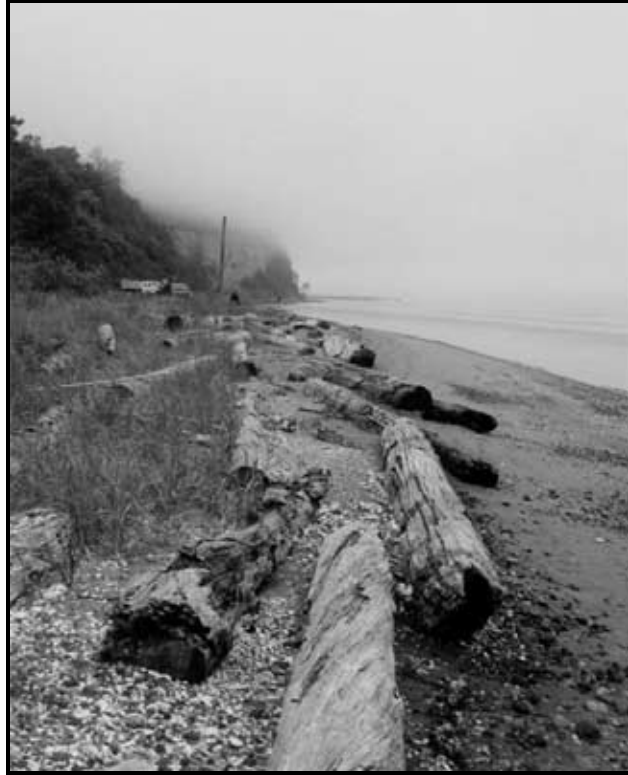
Photo 1. Low energy zone. Coarse woody debris anchored to the beach, with vegetation planted on berm between upper logs.

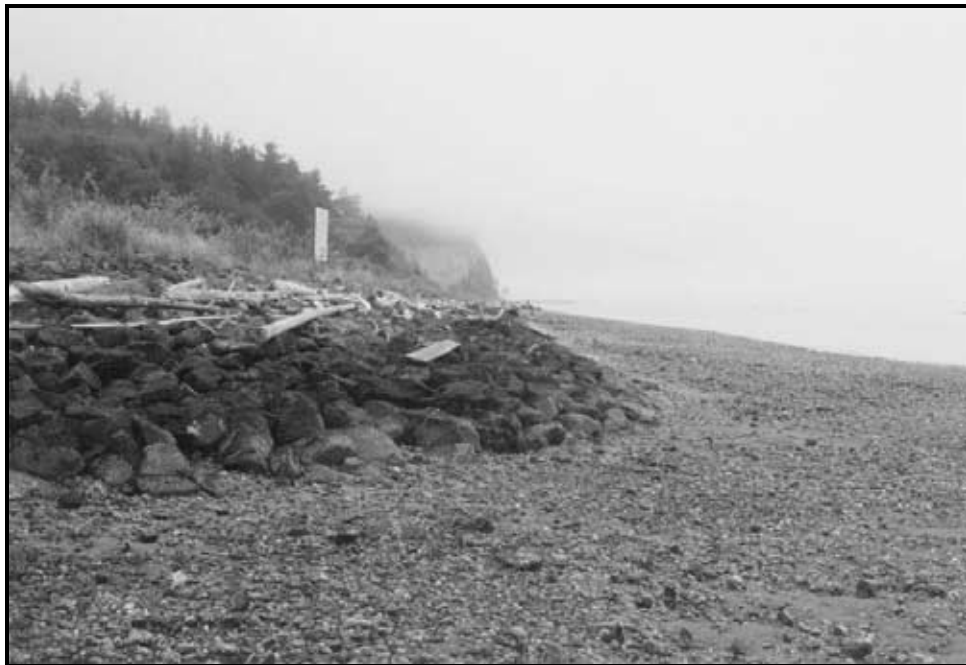
Photo 2. View southwest from northern end of project. A rock revetment is used in the high energy zone.

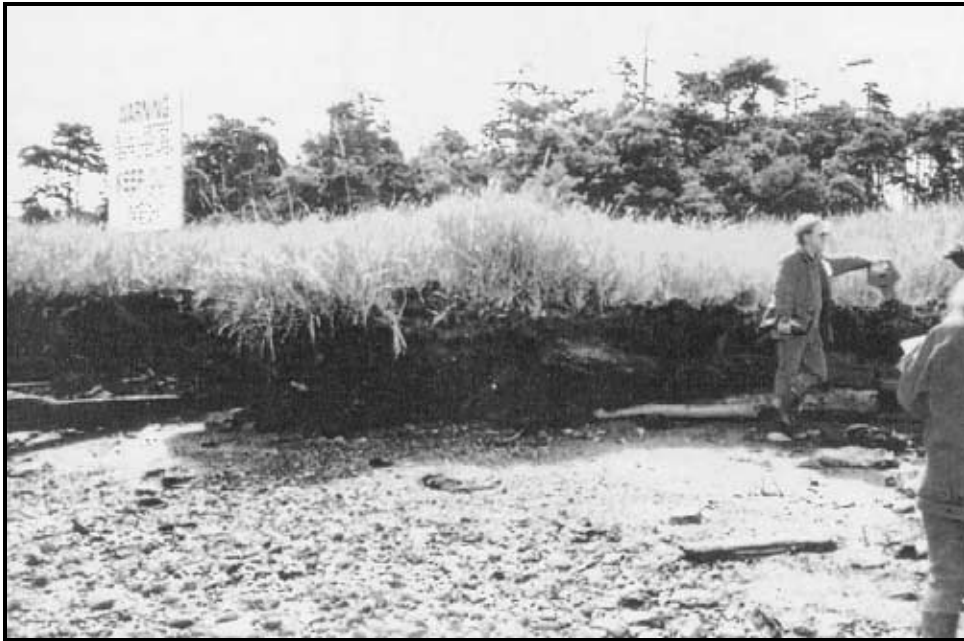
Photo 3. Erosional scarp in bank prior to construction, exposing waste from former landfill (*Photo: courtesy of Bill Kalina, Navy*).

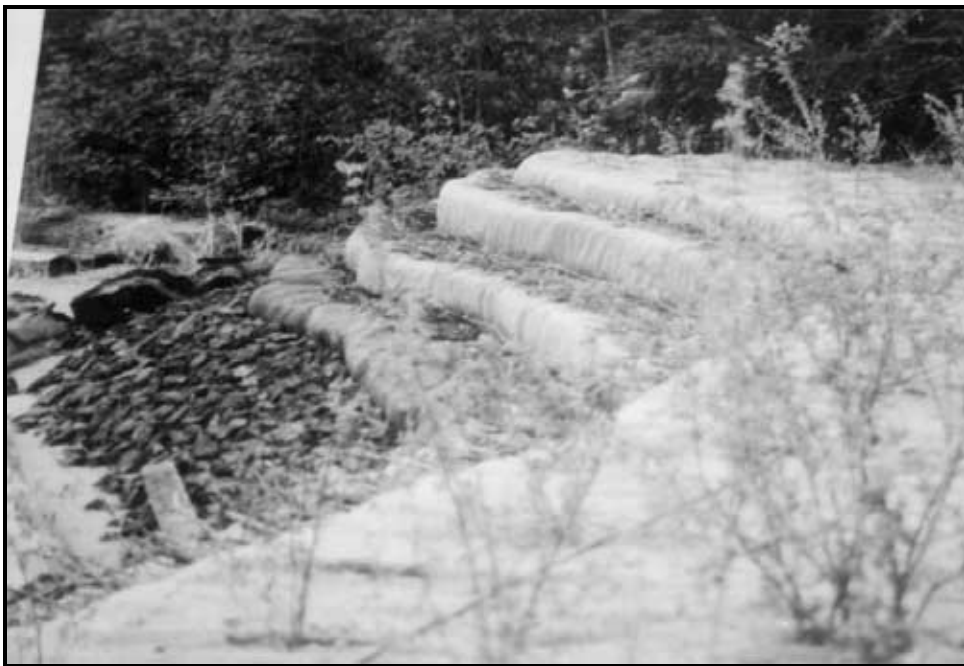
Photo 4. Geogrid lifts are obvious immediately following construction. Geotextile fabric completely covers lifts, but was quickly obscured by vegetation (*Photo: courtesy of Bill Kalina, Navy*).

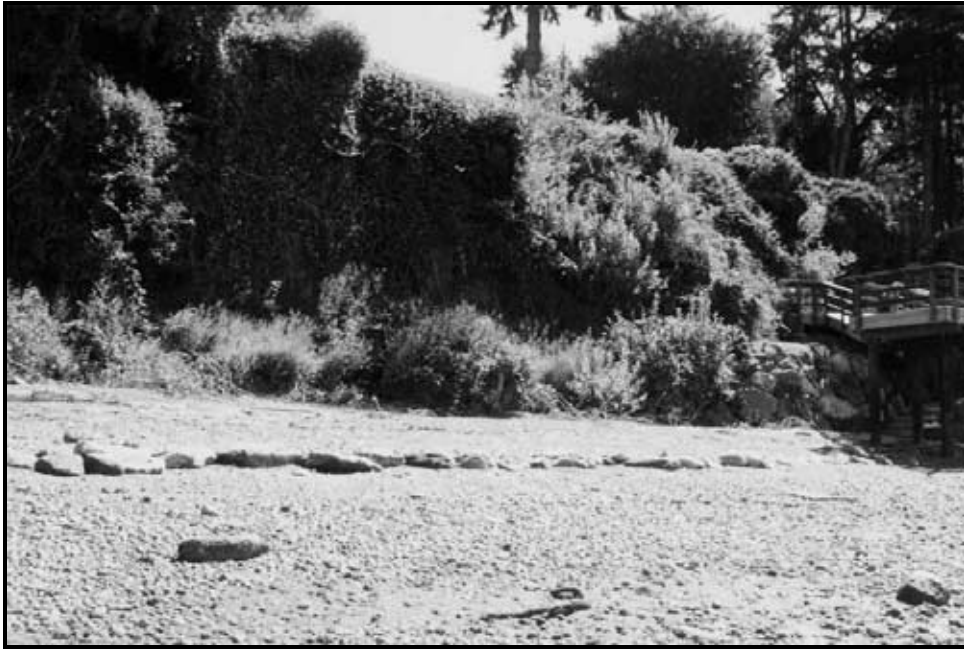
Figure 1. View of Odermat site showing bluff, base of pier, and row of rocks buried in the beach.

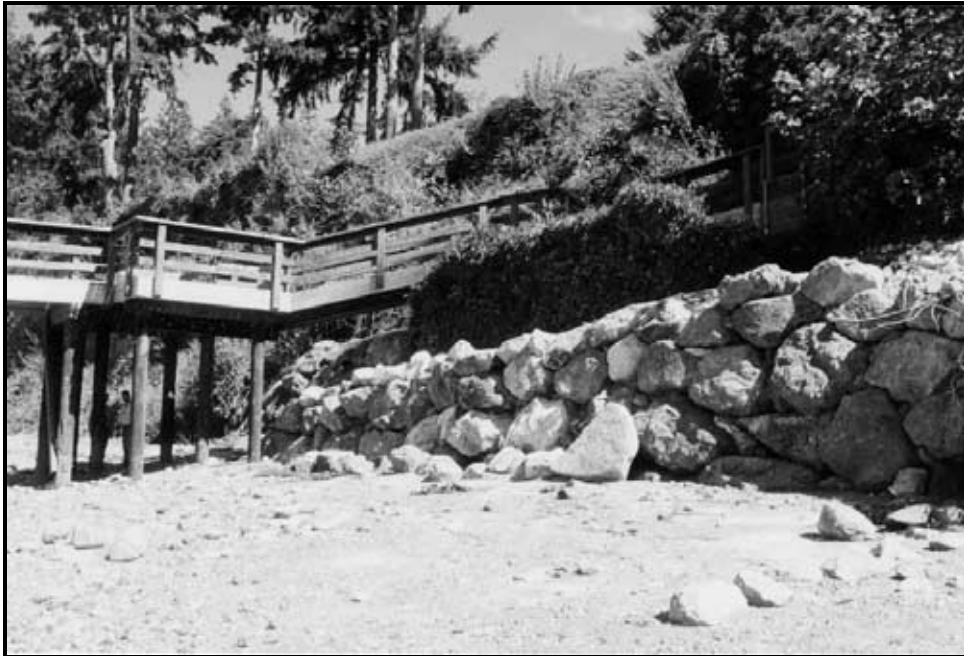
Figure 2. Rock bulkhead constructed on shore south of pier.

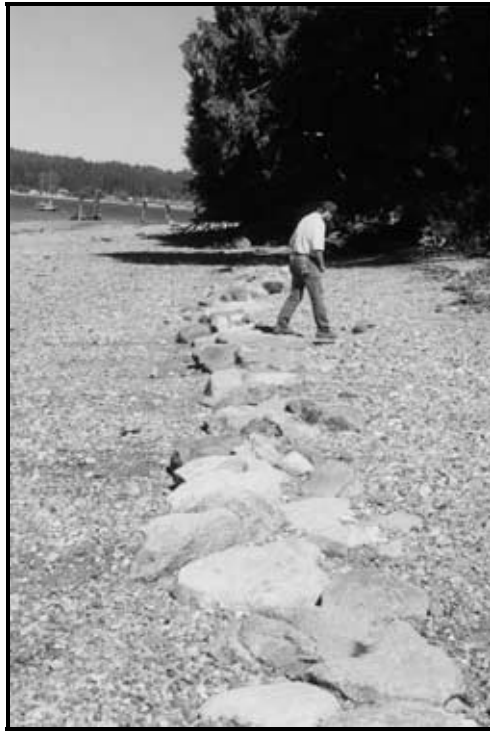
Figure 3. This row of boulders was placed to help stabilize upper portion of gravel beach.
